2021 Pavement Management Plan (PMP) Report Covenant Hills Homeowners Association

GMU Project No. 21-101-00

Subject: 2021 Pavement Management Plan (PMP) Report for Covenant Hills Homeowners Association, Ladera Ranch, Orange County, California

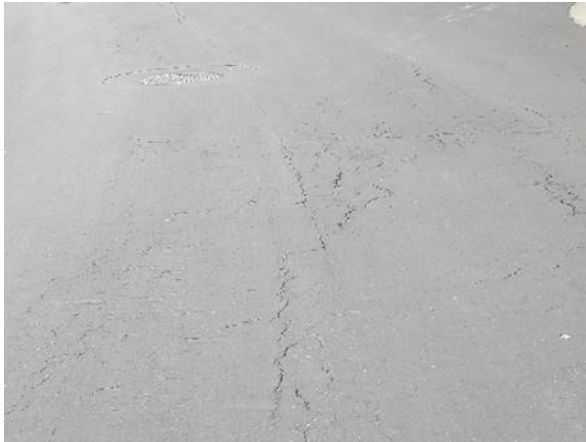
The following photos depict varying levels of pavement surface condition and corresponding PCI. The Broken Area Street photo shows significant alligator cracking, which is a primary driver for the low PCI measured. The Buckaroo Road photo shows pavement that is generally in good condition, containing primarily low-severity weathering and little to no cracking.

Broken Arrow St (PCI = 50, Poor)

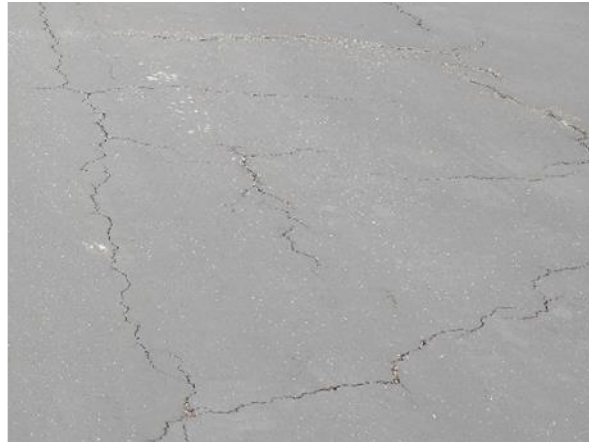
Portalon Ct (PCI = 61, Fair)

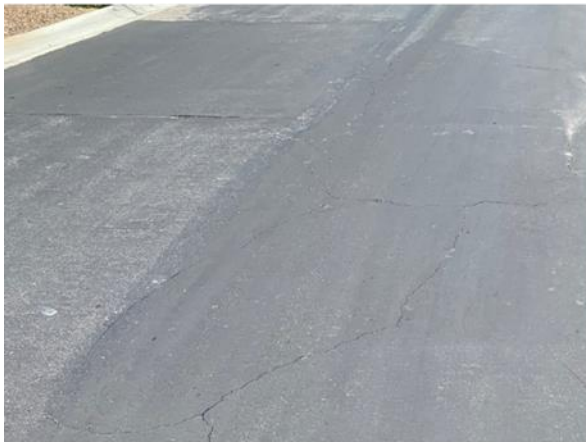
Oberon Rd (PCI = 74, Satisfactory)

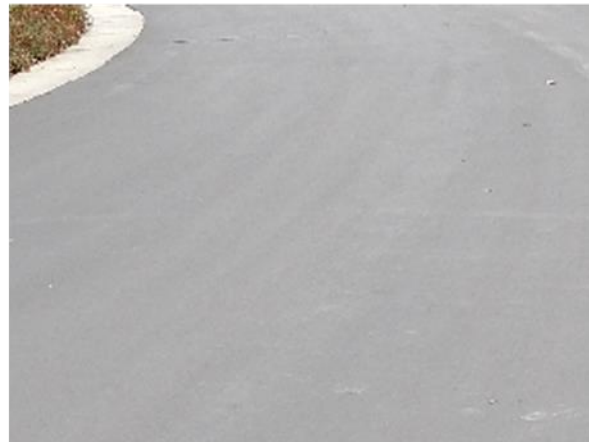
Buckaroo Rd (PCI = 90, Good)
